# EMBANKMENT MONITORING

CLIENT: DEUTSHE BAHN / DB NETZ AG | **HAMM RAILWAY**

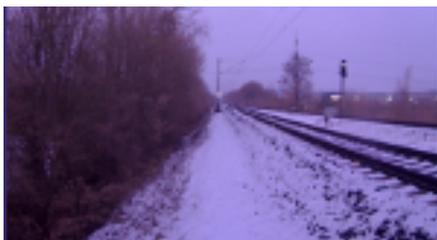
FlatMesh® Camera providing clear images 24/7

During the late winter period, up to 9mm of movement was detected by multiple sensor nodes in the at-risk area during a one-week period, before returning back to the baseline. The FlatMesh® camera images could easily be accessed remotely and clearly showed that the area experienced snow during this time, which indicates that the movement was caused by extreme variations in temperature causing the ground to contract/expand.
